Manhole Inspection Summary

Manhole # S43M__020MH

Insp Date: **5/18/09 8:19 AM**

Location Address: **1641 LANCASTER ST**

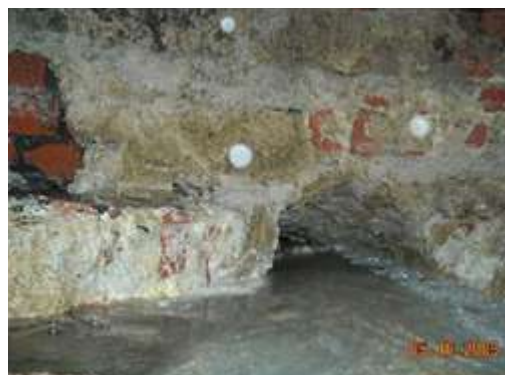
Miscellaneous

PIPE@12 BEFORE CLEANING

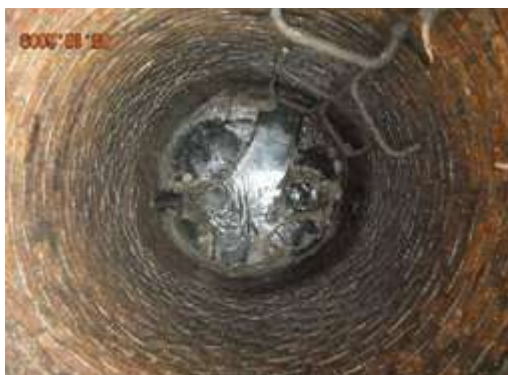
Defect 3

Condition: ☐ Sound ☐ Cracked ☐ Root Intrusion ☐ Deteriorated ☐ Leaks ☒ **Debris**

bench debris

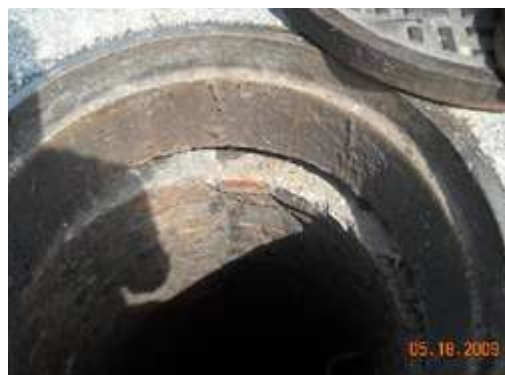
Defect 1

Offset: **1** (in.)

Condition: ☐ Sound ☐ Cracked ☐ Root Intrusion ☐ Loose Brick ☒ **Deteriorated**

FRAME OFFSET; CHIMNEY
DETERIORATED

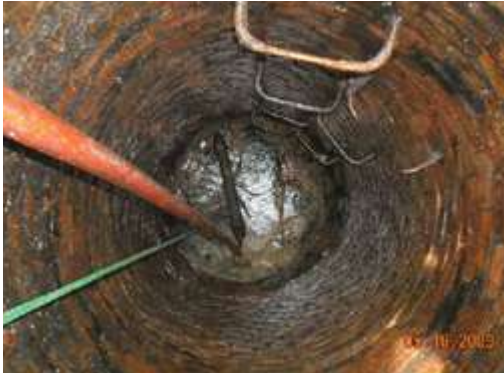
Defect 2

Count: **9** Missing: **1** ☒ **Corroded**

☒ **Evidence Of Surcharge** Depth: **6** (ft.) ☐ Active Surcharge Present

surcharge evidence; missing/corroded steps

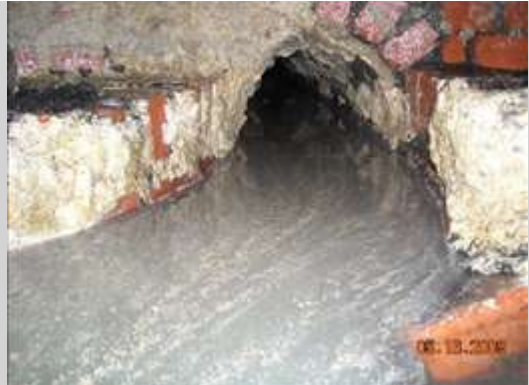
12 O'Clock Outflow

AFTER CLEANING

Pipe Height: **12** (in.) Rod and Bar (Angled)
Pipe Material: **Clay** ☐ Pipe Lined
Invert Depth: **15.79** (ft.) Flow Characteristics: **Slow**
Deposits: ☐ None ☐ Mud ☐ Sludge ☐ Debris ☒ Grease
Silt Depth: **1.5** (in.) Deposits Extent: **Light**
Infiltration: **Weeper** Pipe Seal Cond: **Cracked**

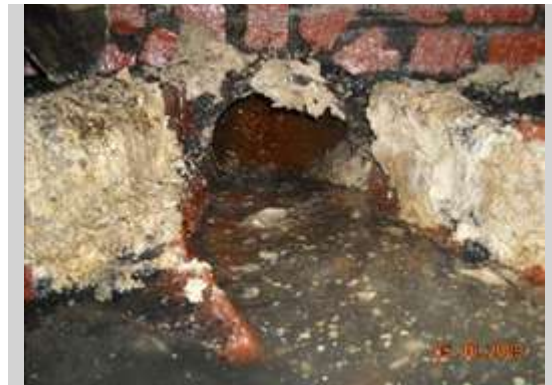
Drop In @ 3 O'Clock

Drop: **Outside** Rod and Bar
Angled: **Yes** Reading: **14.74** (ft.)
Inv Depth: **15.74** (ft.)

Drop Condition: **Clogged**

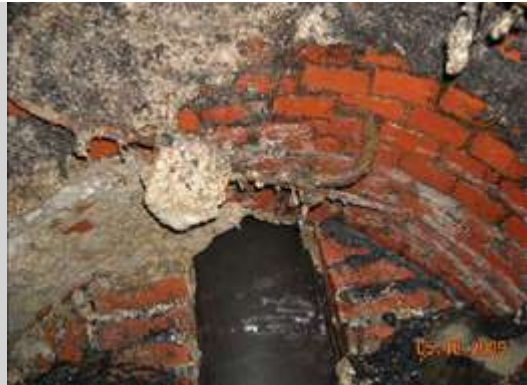
6 O'Clock Inflow

Deposits: ☐ None ☐ Mud ☐ Sludge ☒ **Debris** ☐ Grease

Silt Depth: **1** (in.) Deposits Extent: **Light**

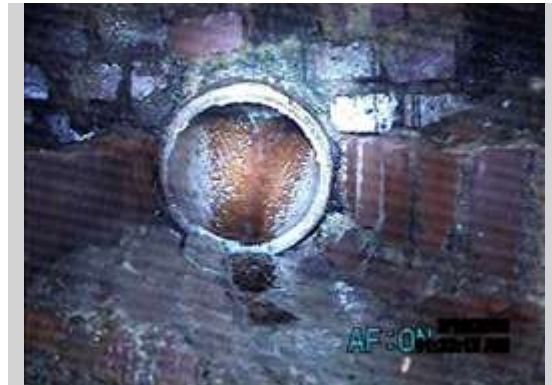
Drop In @ 9 O'Clock

Drop: **Outside** **Rod and Bar**

Drop Condition: **Clogged**
